Audit Photo Report

R-Cloud-24058217

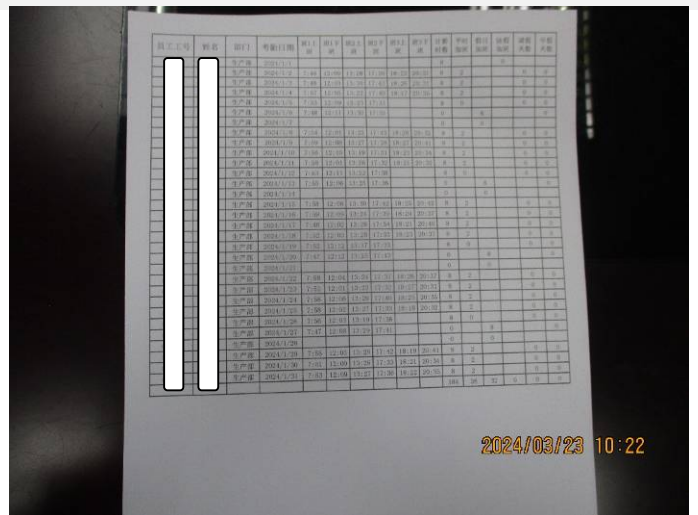
Attendance records (monthly OT exceeded 36 hours)

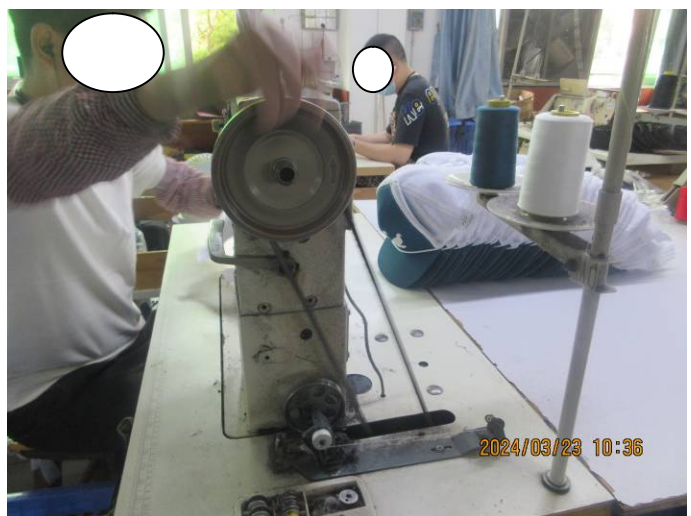
NC- Missing belt guard on sewing machines.

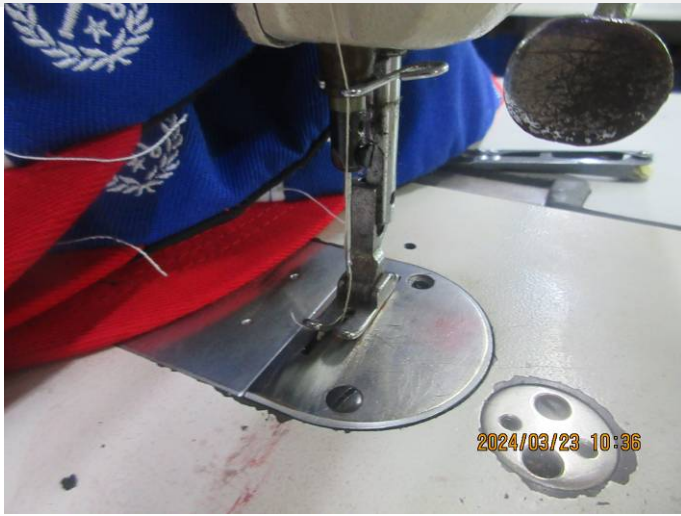
NC-Sewing machine without finger guard.

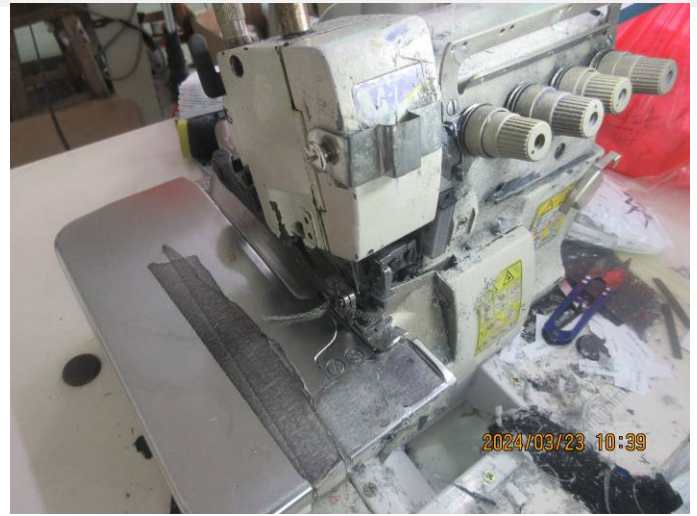
NC-Sewing machine without needle guard.

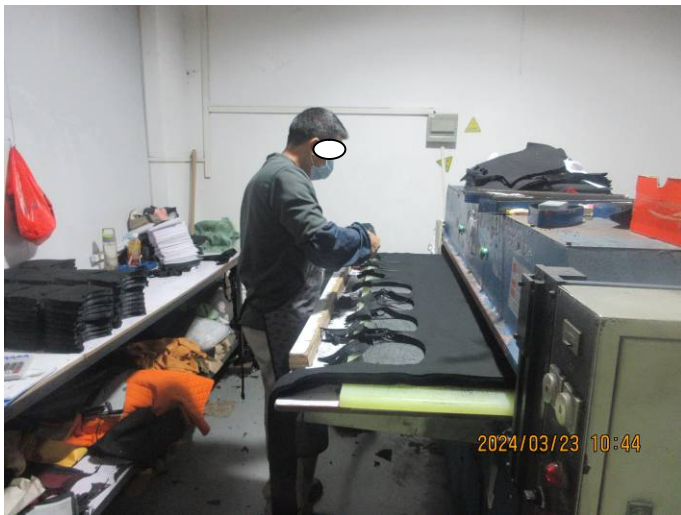
NC-Cutting operator did not use earplugs.

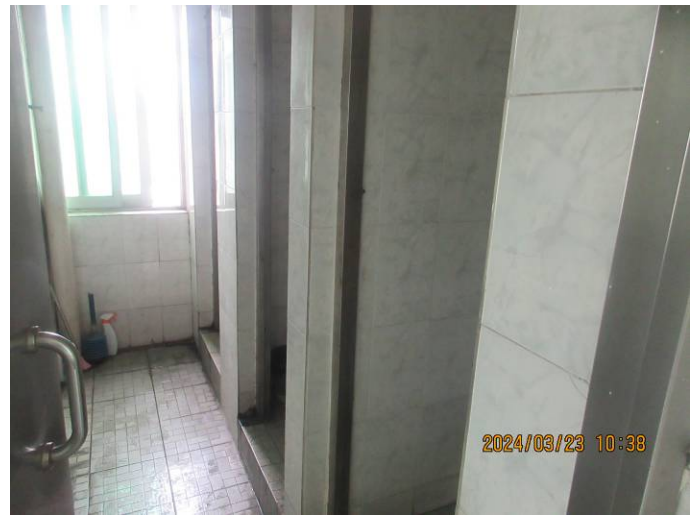
NC-No tissue paper and soap in toilet
